## Installation Story #5 FoamfraxJ Insulation

Industry: Steel  
Location: Northeast United States  
Installation Date: April 2001  
Operating Temperature: 2150°F (1175°C)  
Scope of Job: Ceramic Fiber Lined Ladle Preheat Stand  
3" (76mm) 8 PCF (128 kg/m<sup>3</sup>) Veneer of Foamfrax Grade II Fiber

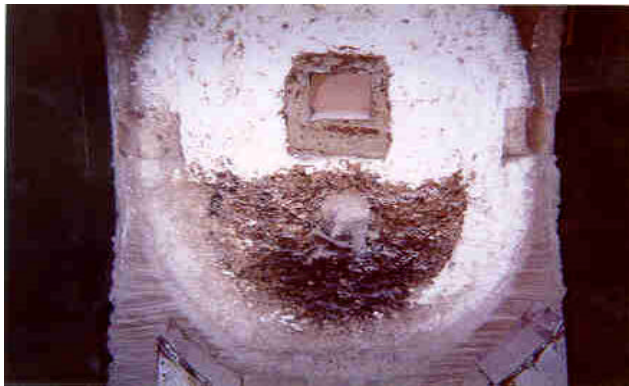
Prior to application of the Foamfrax Insulation, the lining was wet down to minimize the potential for airborne fibers and all loose material scrapped off. This photograph shows the lining after half of the devitrified fiber has been removed. For the removal of any after service refractory material, refer to the product MSDS for proper material handling guidelines.
