Installation Story #7 Foamfraxä Insulation

Industry:	Forging
Location:	Northeast United States
Installation Date:	April 2001
Operating Temperature:	2300°F (1260°C)
Unit:	Batch Forge Furnace
Scope of Job:	3" (76mm) Thick, 8 PCF (128 kg/m ³), Isofoam™ Over Hard Refractory Backwall 3" (76mm) Thick, 8 PCF (128 kg/m ³), Isofoam™ Over Ceramic Fiber Roof

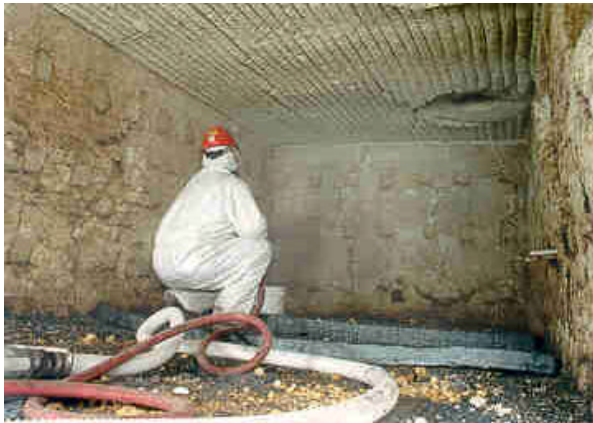
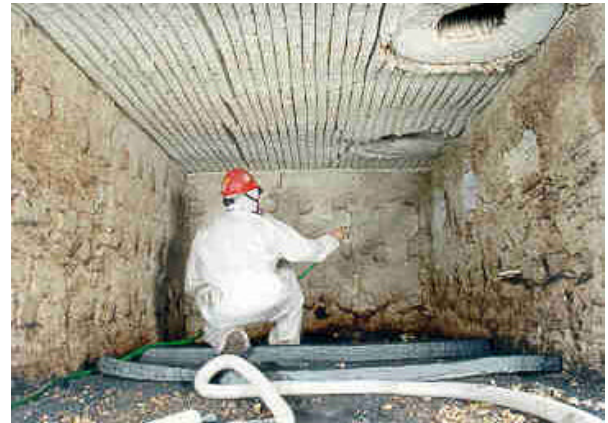
Prior to installation on the hard refractory backwall, all loose material was chipped away and a surface preparation of dilute Fiberstick™ Refractory Cement was applied. The ceramic fiber roof was thoroughly wet with water prior to Foamfrax Installation. For the removal of any after service refractory material, refer to the product MSDS for proper material handling guidelines. Note the shrinkage gaps, which are evident in the roof, due to the challenging operating conditions in this application.

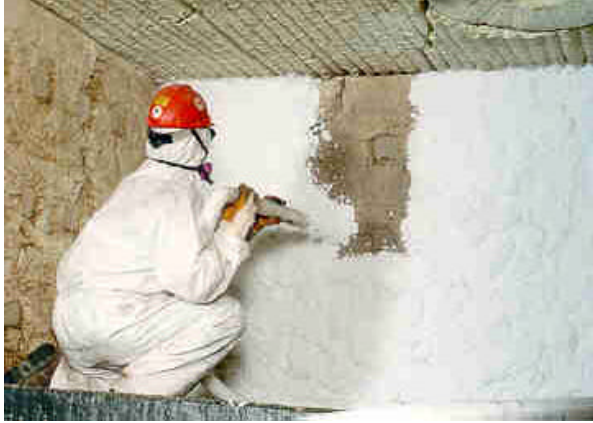
A 3” veneer of Isofoam was gunned onto the surface of the hard refractory backwall and ceramic fiber roof.

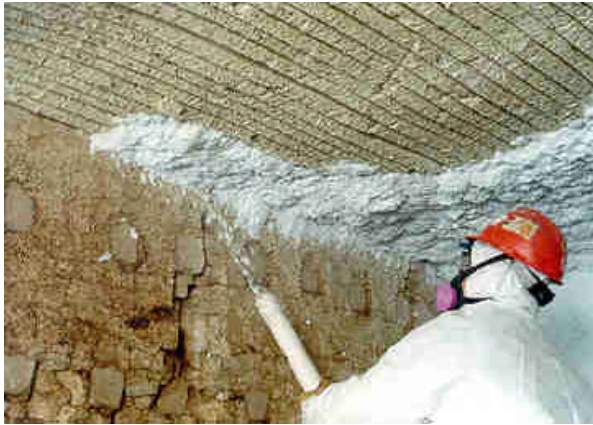
With the installation of Isofoam Insulation, the following customer benefits were realized:

- **Turnkey Installation**
 - A specially trained Unifrax distributor/contractor was able to supply materials, equipment, and installation as a complete package.
- **Extended Service Life**
 - The Isofoam veneer on the existing ceramic fiber roof avoided costly rebuild and associated downtime.
- **Installation Speed**
 - The Isofoam veneer lining was installed in less than two hours and the furnace was immediately available for service.
