## **Installation Story #8 Foamfraxä Insulation**

Industry:	Forging
Location:	Northeast United States
Installation Date:	April 2001
Operating Temperature:	2300°F (1260°)
Unit:	Batch Forge Furnace
Scope of Job:	3" (76mm) Thick, 8 PCF (128 kg/m <sup>3</sup> ), Foamfrax Grade II Fiber Veneer For Miscellaneous Lining Repairs

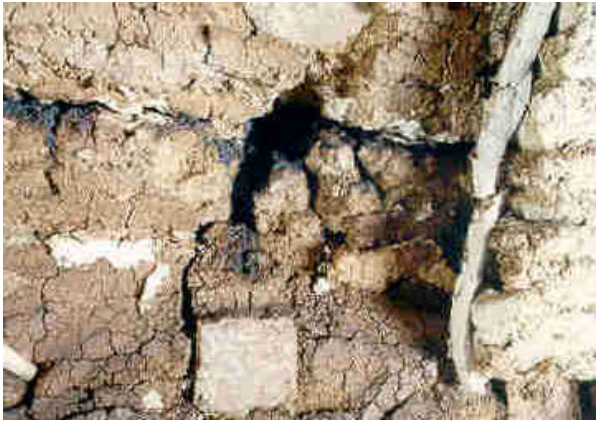
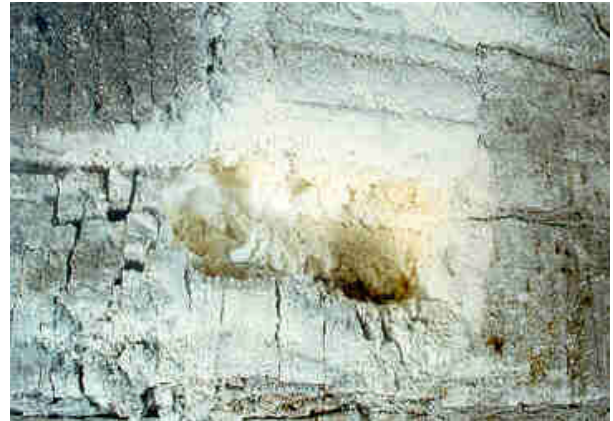
After many years of service, the refractory lined wall and ceramic fiber lined door of this Batch Forge Furnace had become damaged due to thermal shock and mechanical abuse. The size of the damage was large enough to create a hot spot on the furnace casing. A traditional lining repair would be time consuming since it involves tear out and partial lining replacement.
