Installation Story #9 Foamfrax[®] Insulation

Industry: Chemical Processing
Location: Western Canada
Installation Date: June 2001
Operating Temperature: 2150°F (1176°C)
Scope of Job: Ceramic Fiber Lined (Layered Blanket) Ammonia Reformer
3" (76mm), 8 PCF (128 kg/m³) Veneer of Foamfrax Grade II Fiber

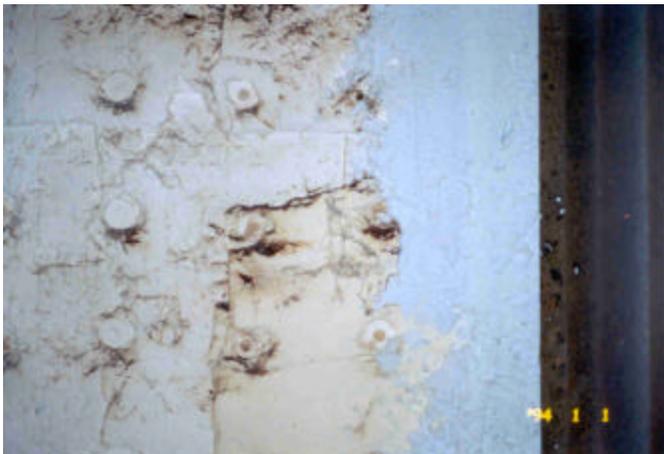
After years of service, the hot face lining of this ammonia reformer had become devitrified and loose in some areas. Prior to the application of the Foamfrax Insulation, all loose/hanging fiber was removed. For the removal of any after service refractory material, refer to the product MSDS for proper material handling guidelines.
