## Installation Story #10 Foamfrax<sup>®</sup> Insulation

Industry:	Steel
Location:	Northeast United States
Installation Date:	May 2001
Operating Temperature:	2300°F (1260°C)
Scope of Job:	Batch Forge Furnace Foamfrax Insulation Full Thickness Composite System, 132”(343mm) 7”(178mm) Foamfrax Grade I Fiber, 8 PCF (128 kg/m <sup>3</sup> ) 62”(165mm) Foamfrax Grade II Fiber, 8 PCF (128 kg/m <sup>3</sup> )

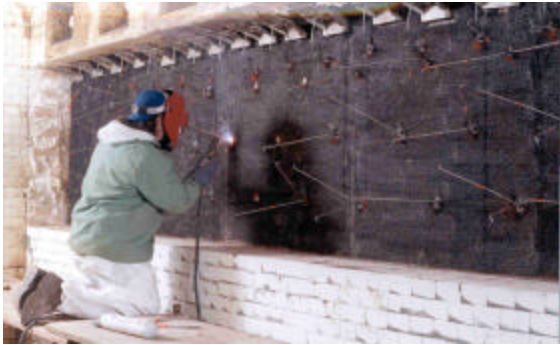
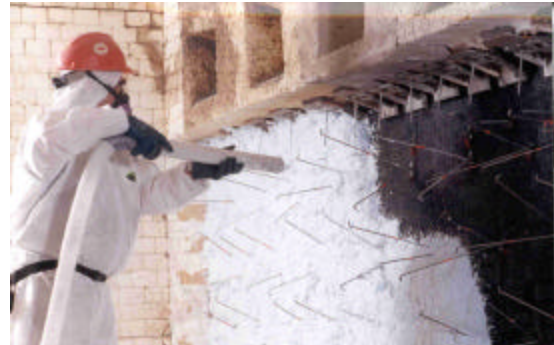
Due to repeated thermal cycling, the insulating firebrick sidewall of this batch forge furnace had begun to deteriorate. A new brick bench was installed and Foamfrax Insulation was selected for a 4'x25' wall section below the sidewall burners. For full thickness Foamfrax Insulation applications, plastic “spider netting” is adhered to the furnace shell and “V” anchors welded in place through the netting. Note that alloy support plates were welded in place to carry the weight of the plastic refractory burner row above the Foamfrax Insulation.

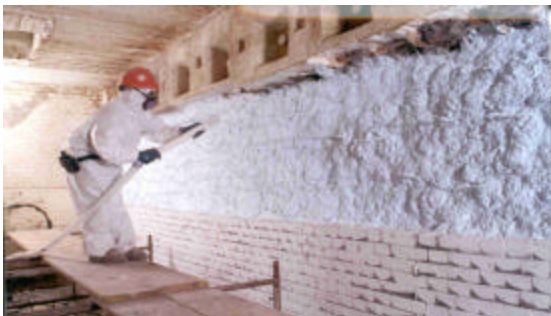
Foamfrax Grade I Fiber was then gunned into the spider netting and around the anchors. The impact velocity and homogeneous consistency of Foamfrax Insulation allow it to flow/work around the “V” anchors without leaving pockets/voids in the lining system. The Foamfrax Grade I Fiber was installed to a 7” (178mm) thickness.

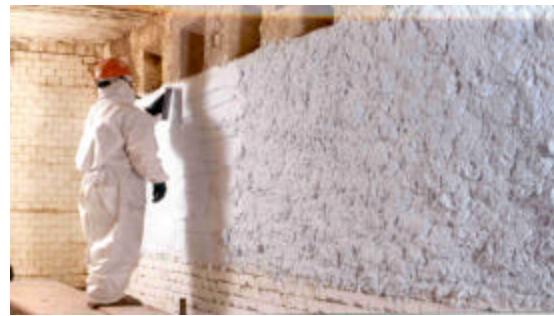
The balance of the wall section (62”, 165mm) was installed using Foamfrax Grade II Fiber. The transition from Foamfrax Grade I Fiber to Foamfrax Grade II Fiber took place at the machine where bags of Foamfrax Grade II Fiber were added.

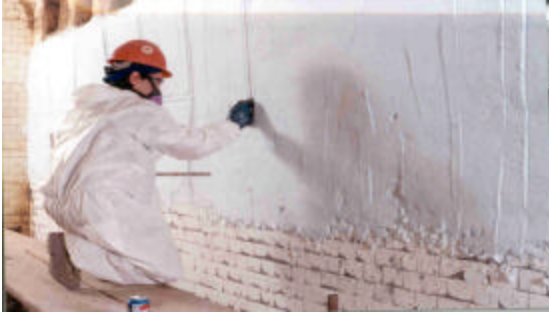
For full thickness applications, the hot face surface must be troweled. A low density (foamy) surface coating of Foamfrax Grade II Fiber was applied and the hotface troweled smooth.

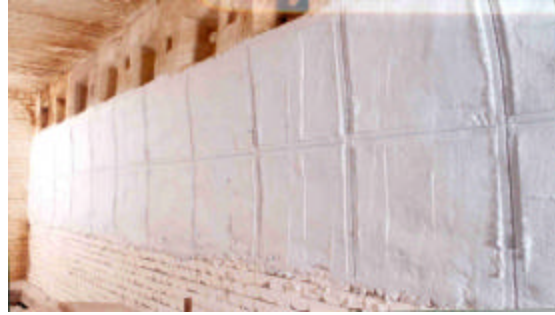
To control surface cracking of the Foamfrax Insulation, score marks were made on a 2'x 2' (610mm x 610mm) grid using a masonry "groover" trowel, similar to the type commonly used for concrete expansions joints.

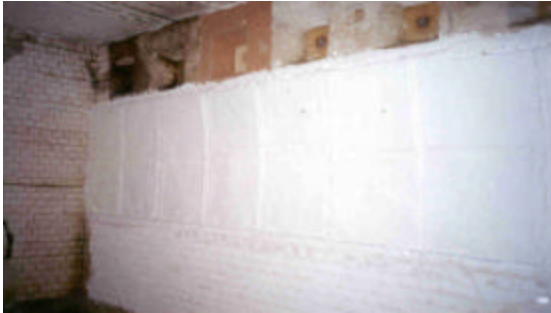
This photograph was taken after 3 months of service at 2300° F (1260° C). Controlled cracking did occur at the score marks. The actual cracks were approximately  $\frac{1}{8}$ " wide and extended  $\frac{1}{4}$ "-  $\frac{1}{2}$ " into the lining. Taken cumulatively, this represents less than 1% shrinkage for the system installed.
